QCONZ
FreshWater
Farm Plan

Fresh water farm plan report

Test Farm - SINGLE ENTERPRISE
(Crops)

February 2024

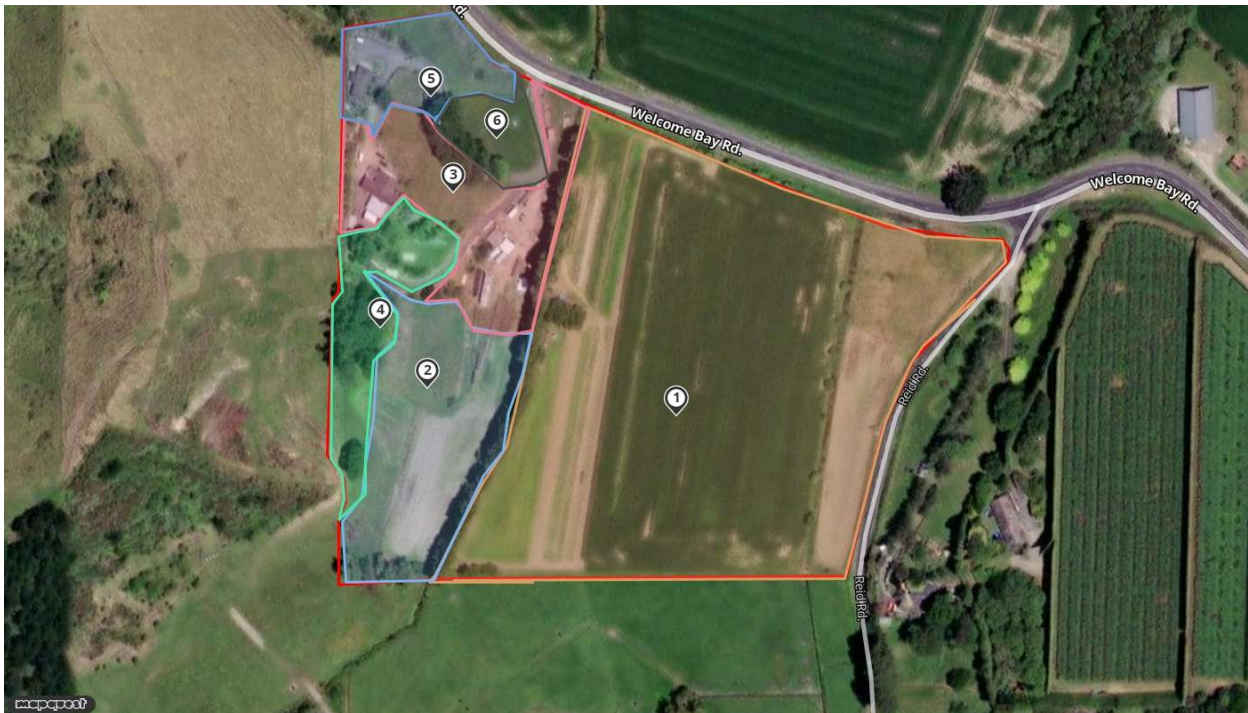
MAP 04

LAND UNIT DETAIL				
Map Number	Land Unit	Size (Ha)	Topography	Farming Activities
1	Crop Area	4.5	Flat	Vegetable growing - Potato Farm
2	North paddock	1	Flat	Sheep farming - Dozen ewes
3	Farming Operations Area	0.8	Easy Hill	Vegetable growing - Potato Farm, Sheep farming - Dozen ewes
4	Retired Bush and Trees	0.5	Easy Hill	
5	Accommodation Area	0.4	Flat	
6	Secondary Crop Area	0.2	Flat	Vegetable growing - Potato Farm

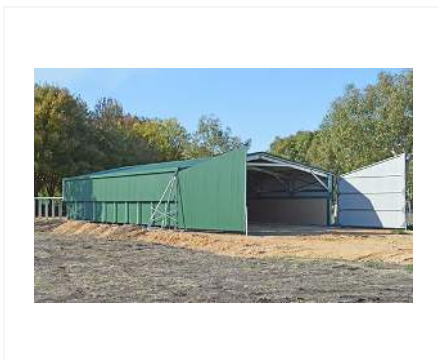
1 FERTILISER SHED		
Shed was constructed in the 1990s and is made from timber and iron, It is structurally sound and easily holds 50 tons of fertiliser.	Category	Infrastructure
	Container	Fertiliser storage
	Associated Risk	N/A
	Actions	#438

Fertiliser shed rebuild		Due	28/02/2025
		ID	# 438
this shed is showing its age and need some repairs, and a new section added. These are planned to be completed in early summer 2025 which will involve digging out some new areas and rebuilding other parts.			
Action Category	New or Existing	Map Number	Page Category
Supplementary	New	07	Infrastructure
Regulatory Requirement	Mapped Item Type	Mapped Item Name	Land Unit(s)
N/A	Fertiliser storage	Fertiliser Shed (3)	Farming Operations Area
Risk			
Aging infrastrucuture

Fertiliser shed rebuild		Due	28/02/2025
		ID	# 438
this shed is showing its age and need some repairs, and a new section added. These are planned to be completed in early summer 2025 which will involve digging out some new areas and rebuilding other parts.			
Land Unit(s)	Page Category	Container	Item
Farming Operations Area	Infrastructure	Fertiliser storage	Fertiliser Shed

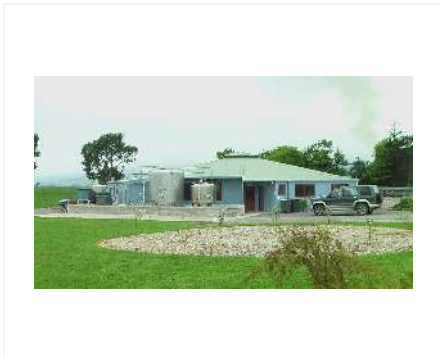
3 VEGE SORTING SHED

Vege Sorting shed	Category	Infrastructure
	Container	Sheds
	Associated Risk	N/A
	Actions

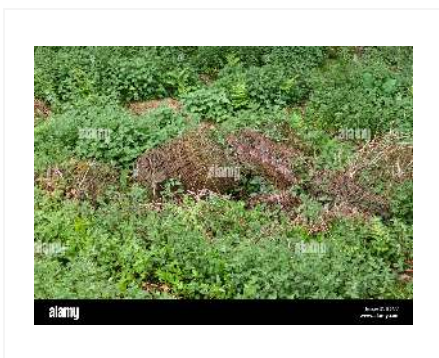
6 RUBBISH		
The rubbish dump is legacy and no longer used (stopped using in 2015). Some leechage risk remains from the previous 30 years of use (different owners)	Category	Infrastructure
	Container	Rubbish dumps
	Associated Risk	N/A
	Actions	#408

fix rubbish dump		Due	28/05/2026
		ID	# 408
Improve rubbish disposal			
Land Unit(s)	Page Category	Container	Item
North paddock	Infrastructure	Rubbish dumps	Rubbish

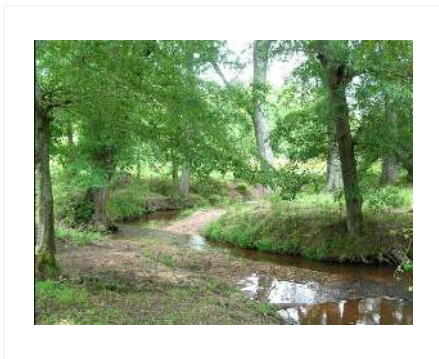
2 WIAHOUHOU RIVER

This small river intersects the property through directly from the Southern boundary and exits at the Northern end. While small, the river is an important water source.	Category	Waterway	
	Container	River	
	Associated Risks	N/A	
	Actions	#439	
	Fenced	Yes	
Width	<1m	Fencing %	100%
Riparian Planted	Yes	Riparian Planting %	100%
Riparian planting margin	4m

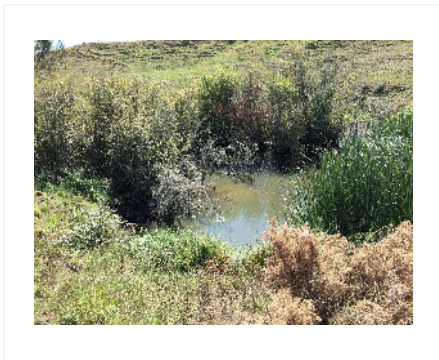
3 DUCK POND

A small pond is situated near the northwestern corner. The pond is murky and contaminated with insect life, but no aquatic creatures.		Category	Waterway
		Container	Pond
		Associated Risks	N/A
		Actions	
		Fenced	
Width		Fencing %	
Riparian Planted		Riparian Planting %	
Riparian planting margin

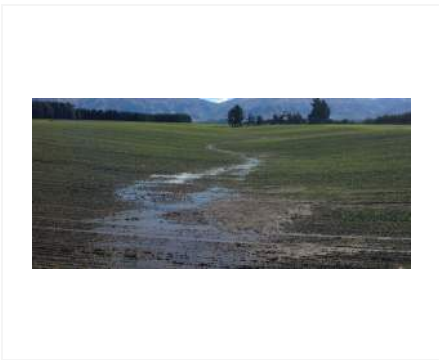
1 SWAMPY AREA

There is a small swamp near the South western boundary which after rain will retain water for several weeks. It is an unused area of the property.	Category	Land and Soil
	Container	Areas that hold water
	Associated Risk	Sediment runoff to waterways
	Actions	#440

Create buffer zones or grass strips in and around CSAs to act as filters by slowing overland flow		Due	31/12/2024
		ID	# 440
New buffer zone under development with extra large grass strip			
Action Category	New or Existing	Map Number	Page Category
Supplementary	New	09	Land and Erosion
Regulatory Requirement	Mapped Item Type	Mapped Item Name	Land Unit(s)
N/A	Areas that hold water	Swampy area (5)	North paddock
Risk			
Critical Source Areas are present on farm

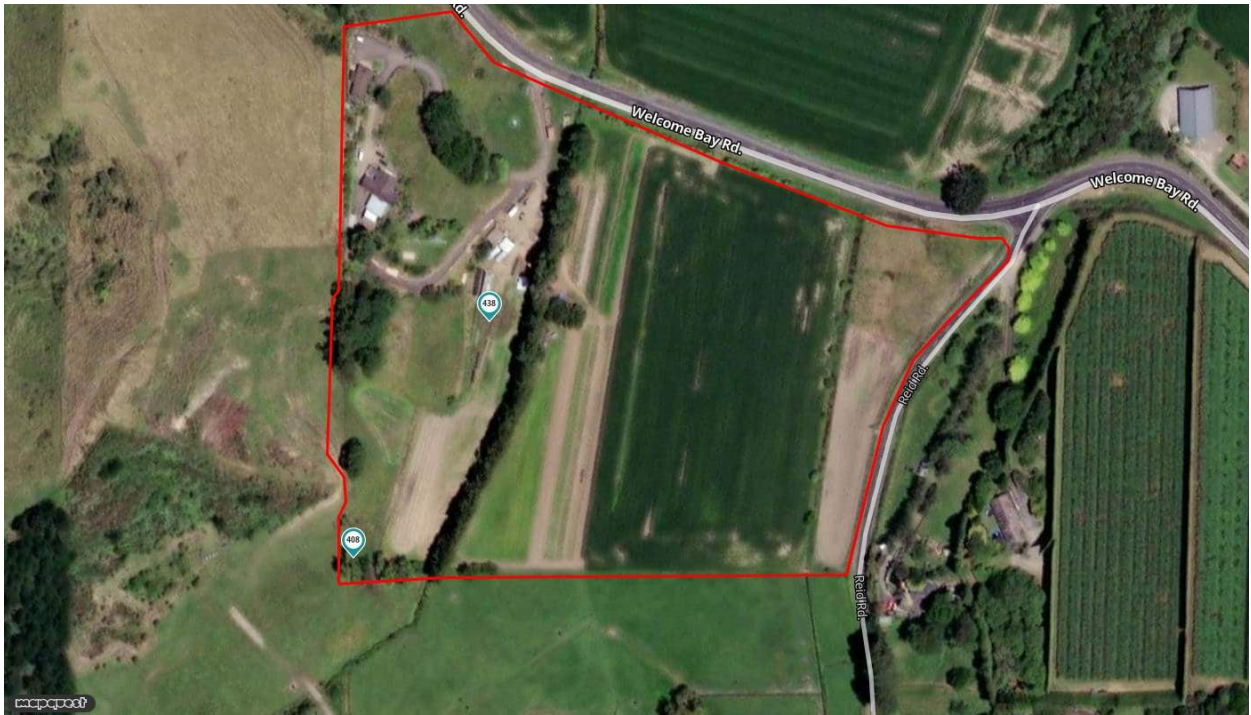
MAP 15

Future physical works have been mapped as follows:

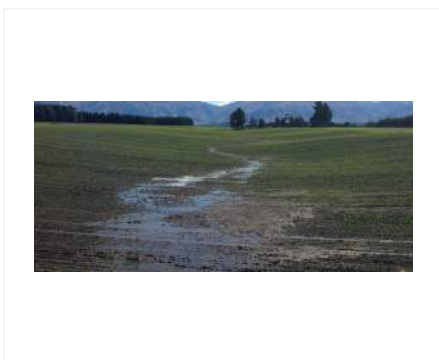
Temporarily fence off CSA when grazing the paddock during risk periods		Due ID	Closed (was due 30/05/2024) # 404
asdasfsgsdfgdfg			
Action Category	New or Existing	Map Number	Page Category
Regulatory	New	07	Infrastructure
Regulatory Requirement	Container	Item	Land Unit(s)
dfgdfg	Fuel storage	Fuel storage item	North paddock
Risk			
Critical Source Areas are present on farm

Close Date	Detail
19/01/2024	fixed now
